FACTORS AFFECTING LOAD-HAUL-DUMP OPERATOR VISIBILITY IN UNDERGROUND MINING

T. EGER^{1,2}, A. W. SALMONI¹, R. WHISELL³

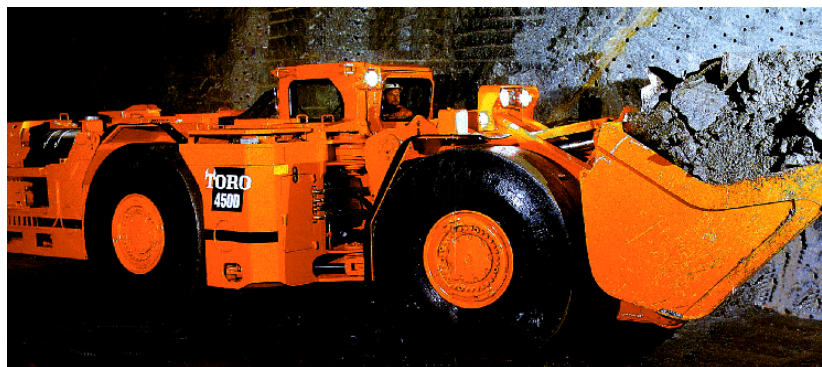
Figure 1: Example of a typical LHD vehicle.

The design of the LHD vehicle, particularly one with a protective cab, results in restricted line of sight and blind spots. Of note is vision over and around the bucket (Boocock, Corlett, & Naylor, 1994; Vergunst, 1992) and the significant blind spots produced by the cab roof supports/posts (Boocock, Corlett, & Naylor, 1994; Marx, 1987; Rushworth, 1996). Both drivers and researchers have noted that vehicle lights both restrict vision and are often not placed so that the roadway is adequately lit for proper operation (Boocock & Weyman, 1994; Rushworth, 1996). The other major complaint is that the seat position in the LHD does not allow the driver to adopt a posture to afford an adequate field of vision. As concluded by Marx (1987), "Ergonomically designed components are hard to find on machinery used in underground mining". For most models of LHDs, carrying capacity and fit within a confined environment have been the prime engineering design concerns.

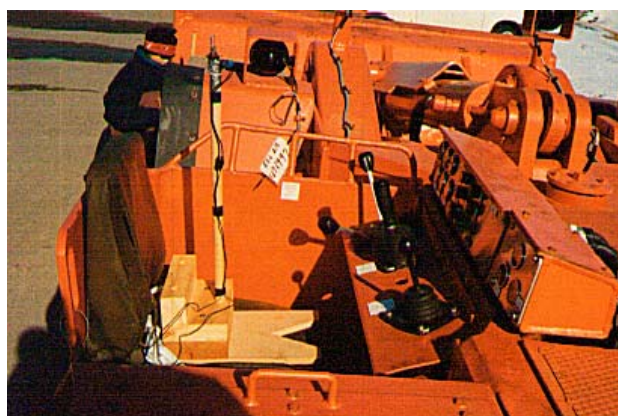
Figure 2: Seat point indicator with light filament located in the LHD operator's seat.

The first step in conducting the line of sight measurements was to secure a light filament to the operator's seat at a height representative of the eye position of a five foot seven inch, 65 kilogram person (Figure 2). Four reference points extending out from the operator's position (to the left, in front, to the right, and behind) were then marked. The reference positions were then used to trace out a rectangle. Locations were marked off on the perimeter of the rectangle at known distances from the LHD. Sight lines were then evaluated at each of the marked locations (Figure 3). A measurement rod with a sliding mirror was used to record the height from the ground at which the light filament could just be seen in the mirror. If the light was not visible at that location, the machine part responsible for the visibility restriction was recorded. Mathematical equations were employed to extrapolate line of sight distances to the ground, to one meter above ground (approximating a kneeling person), and 1.7 meters above ground (representing a standing person). This information was then used to create the line of sight charts (Figure 4). A test/retest procedure was followed using an Elphinstone R1500 to insure the reliability of the testing protocol.

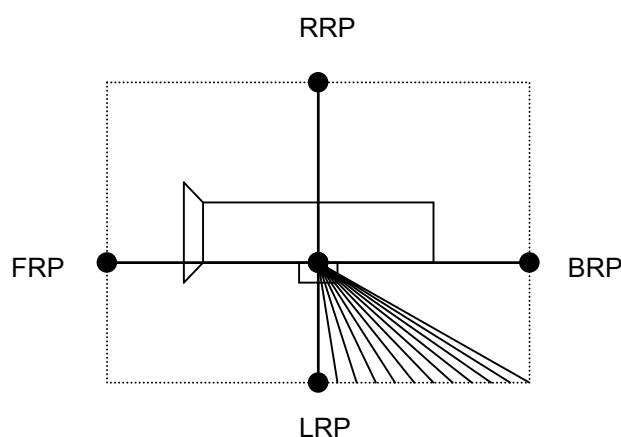
Figure 3: The location of the reference points is shown. (LRP: left reference point, FRP: front reference point, RRP: right reference point, BRP: back reference point) The dashed lines forming a rectangle represent the marked locations where line of sight measurements are taken. The solid lines from the operator's position represent line of sight measurements taken in the back left quadrant.

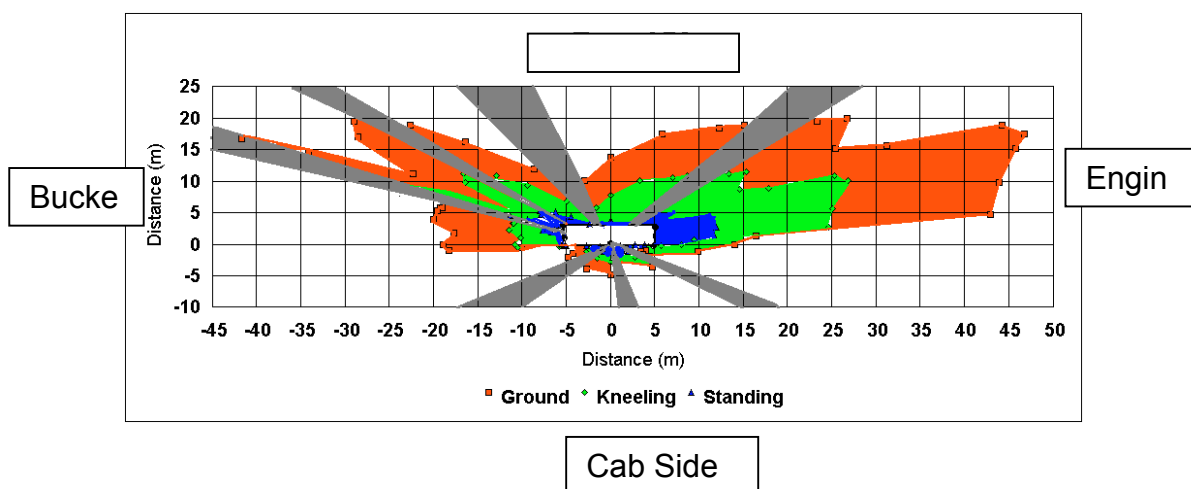
Figure # 4: Example line of sight diagram for an 8 Yard LHD vehicle with a cab. The operator is positioned at position (0,0) on the graph. The LHD vehicle is represented by the white rectangle. The area from the operators position that is not visible to the ground is shown in red, the area in which a kneeling person could not be seen is shown in green and the area in which a 1.7 meter tall person could not be seen is shown in blue. Complete blockages (blind spots) are shown in grey. Starting from the operators position and moving clockwise, the machine characteristic responsible for the seven blind spots are; cab back, cab post, light bracket and boom, light bracket, cab post, cab post, and cab post.

Line of sight graphs were produced for each of the 12 LHD models evaluated (Figure 4 & Figure 5). No two machines had the same results however there were a number of trends. Preliminary analysis has shown the following machine characteristics are primarily responsible for blind spots from the operator's position:

- Operators cab (posts, and back)
- Light and light bracket combination (cross bracket & 4 light combination, large post & square light combination)

As expected, the distance an operator can see to the front and the back of the LHD was greatly effected by machine size. Visibility was generally better from the smaller LHDs (3 yard bucket) compared to the larger LHDs (8 yard bucket). Visibility was also better if the machine did not have a full cab. Although this result was expected, the size of the blind areas created by the cab is a concern and should not be ignored particularly since the trend in new LHD models is to have a full cab installed on the vehicle.
